Appendix F

Structures Visual Inspection Forms

FACILITIES CONDITION ASSESSMENT REPORT

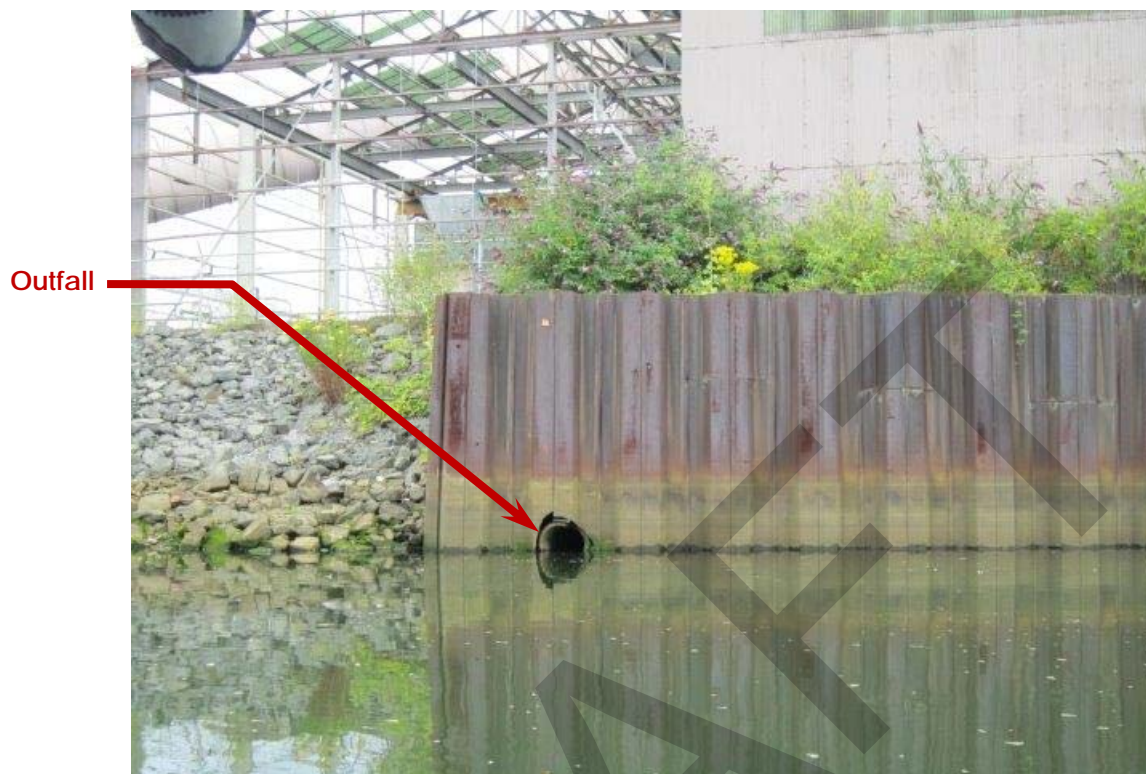
- Concrete outfall end approximately flush with steel sheet pile bulkhead (Photo 1).
- The size, support, and condition of the outfall could not be observed.

OF04-01: Concrete Outfall

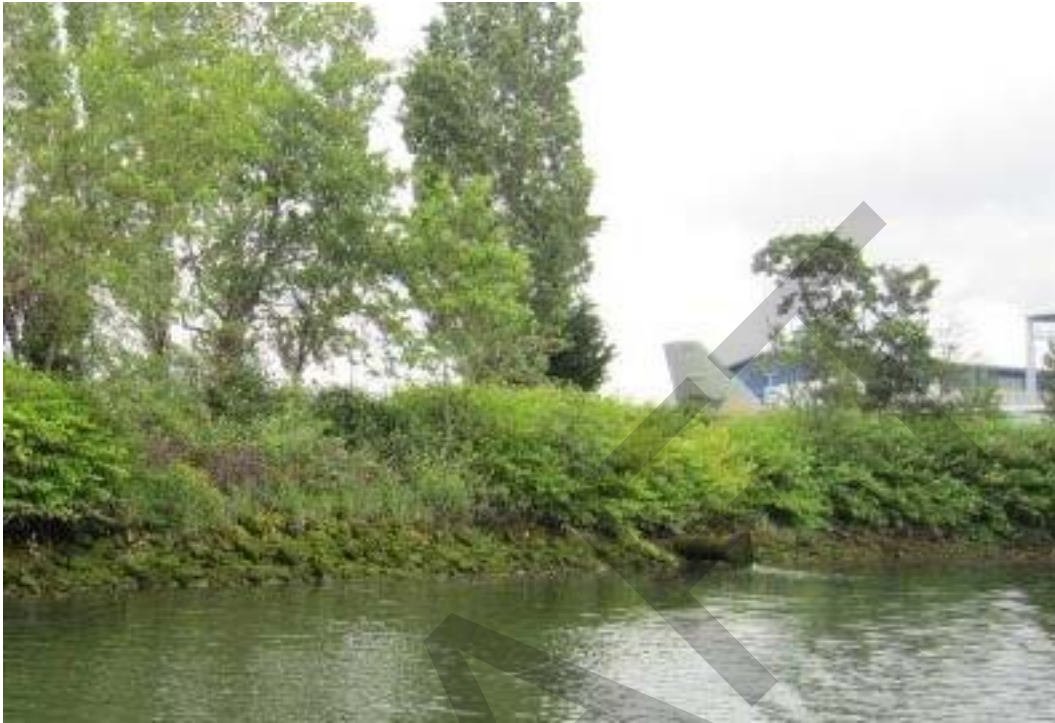
Photo OF09-01: Outfall (Looking North)

- Outfall with duckbill valve surrounded by riprap. The pipe size, material and support were not observed (Photo 1).

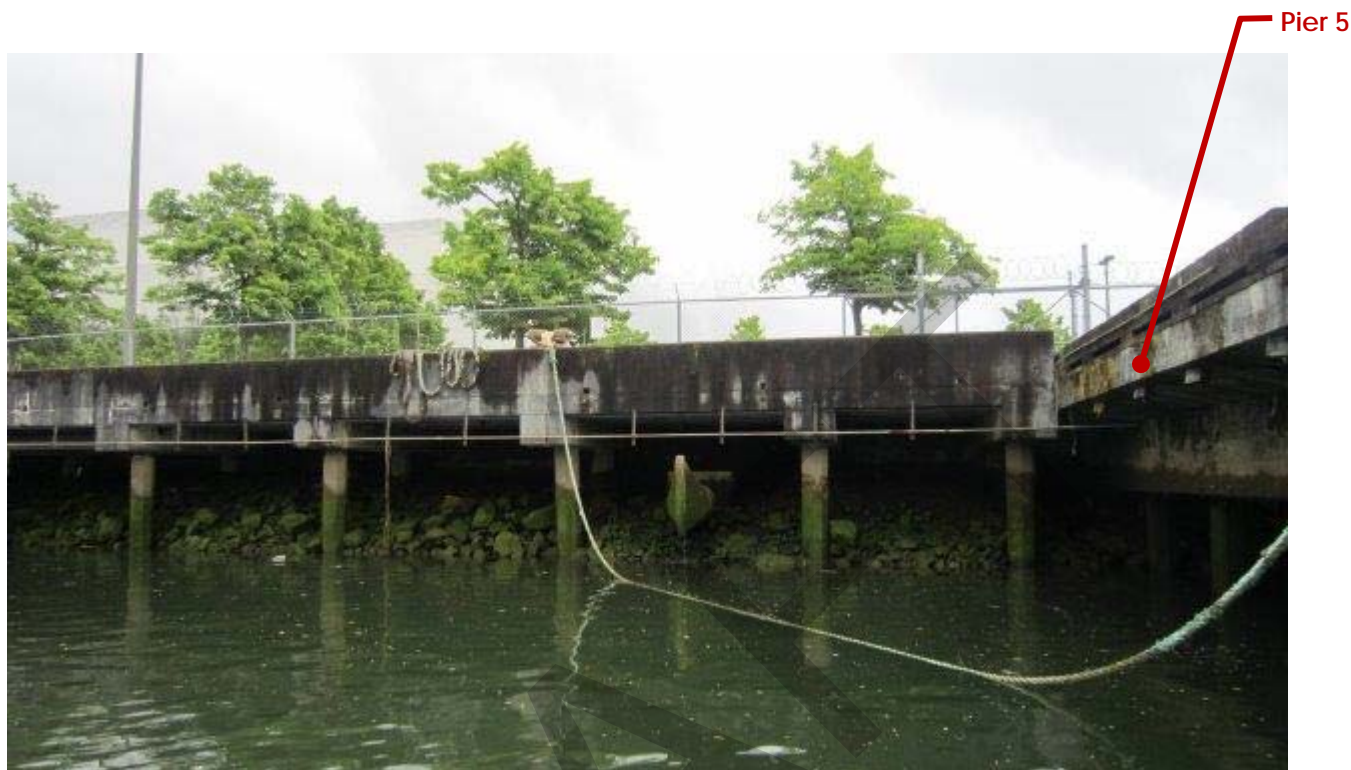
Photo OF11-01: Outfall Between Piers 4 and 5 (Looking South)

- Outfall with duckbill valve surrounded with riprap and slightly overhangs beyond the shoreline. The pipe size, material, and support condition were not observed (Photo 1).
- Located in Clip 6 under the wharf between piers 4 and 5.

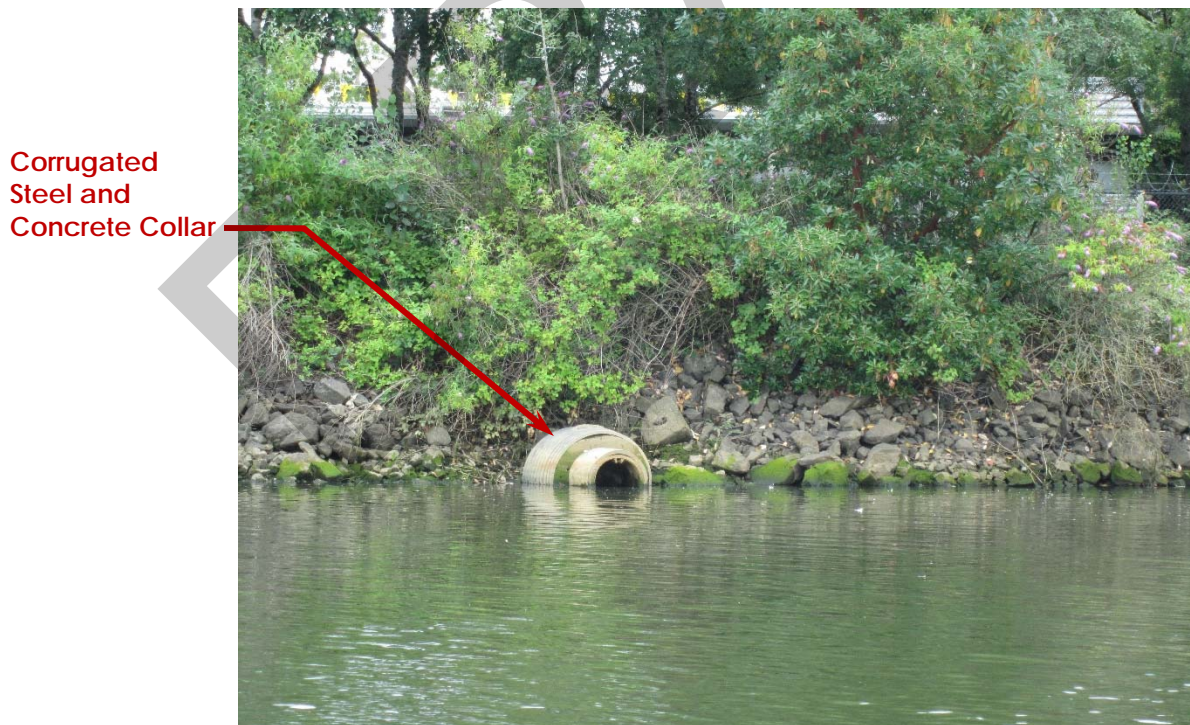
Photo OF12-02: Outfall (Looking East)

- Outfall with armor and corrugated steel encased concrete collar is projected beyond the shoreline. It does not appear that riprap surrounds the outfall (Photos 1 and 2).
- Pipe size, material, and support condition were not observed.

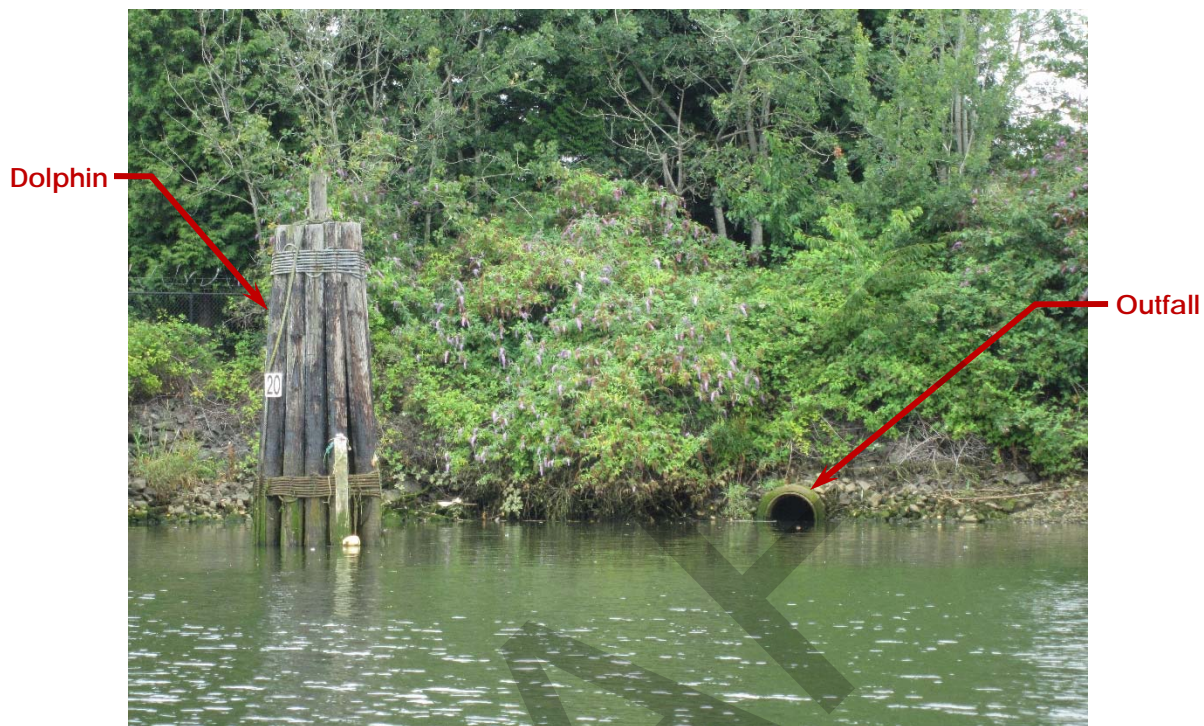
Photo OF13-01: Outfall South of Dolphin (Looking East)

- Outfall is encased with concrete and projects slightly beyond the shoreline. It is surrounded with riprap (Photos 1 and 2).
- Pipe size, material, and support condition were not observed.

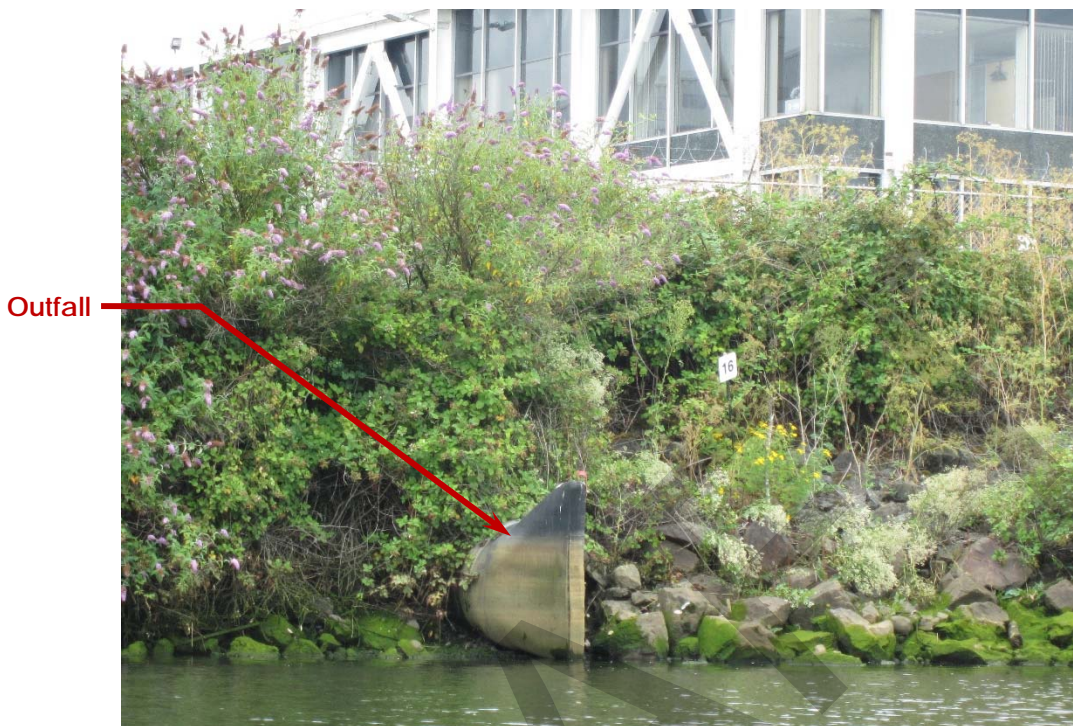
Photo OF15-01: Outfall (Looking East)

- Outfall with duckbill valve projecting from the riprap armor (Photo 1).
- Pipe size, material, and support condition were not observed.

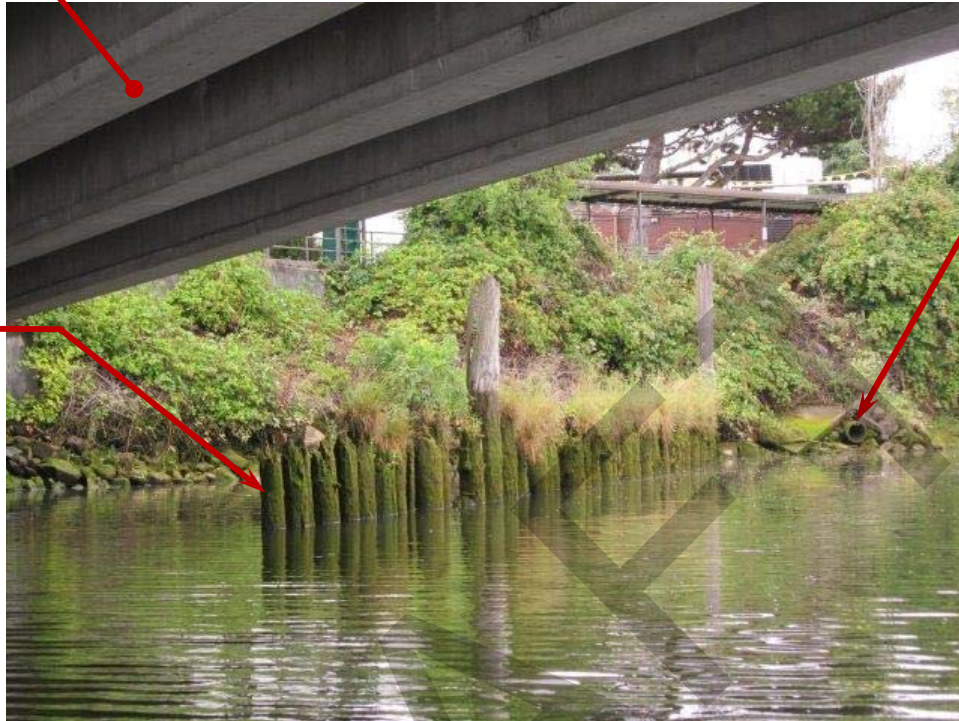
Photo OF17-01: Outfall (Looking East)

- Outfall pipe projecting beyond the shoreline and surrounded with riprap and concrete panel rubbles (Photo 1).
- Pipe size, material, and support condition were not observed (Photo 2).

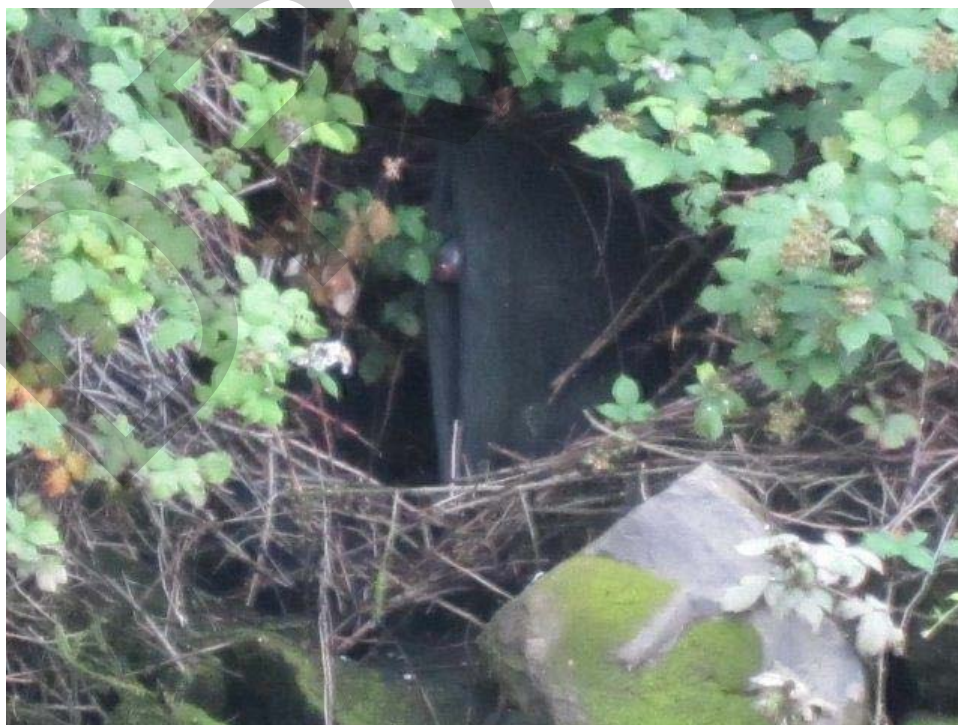
- Outfall with a duckbill valve is nested in the bushes over the shoreline and appears to be surrounded with riprap (Photos 1 and 2).
- The valve appears to be open (Photo 2).
- Pipe size, material, and support condition were not observed.

Photo OF20-02: Enlarged Outfall Valve

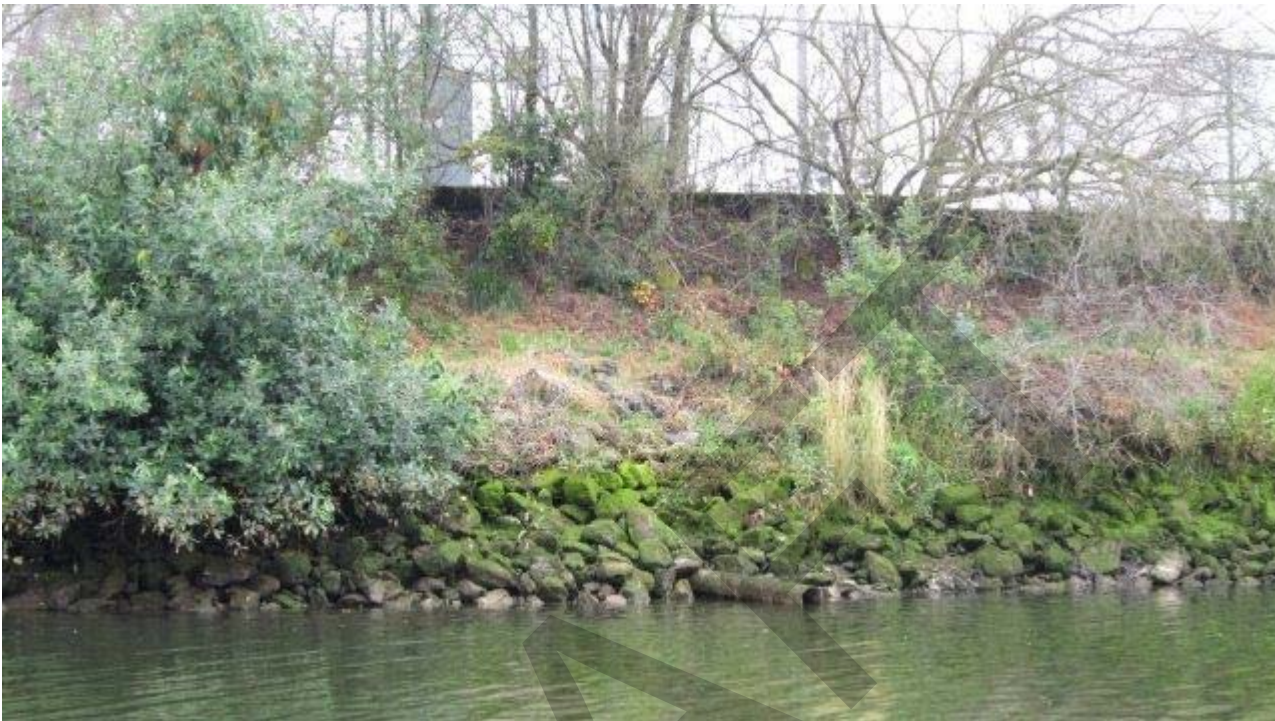
Photo OF21-01: Outfall (Looking West)

- Corrugated steel pipe projecting several feet beyond the shoreline surrounded by riprap (Photos 1 and 2).
- Moss growth around the pipe (Photos 1 and 2).
- Pipe size, material, and support condition were not observed.

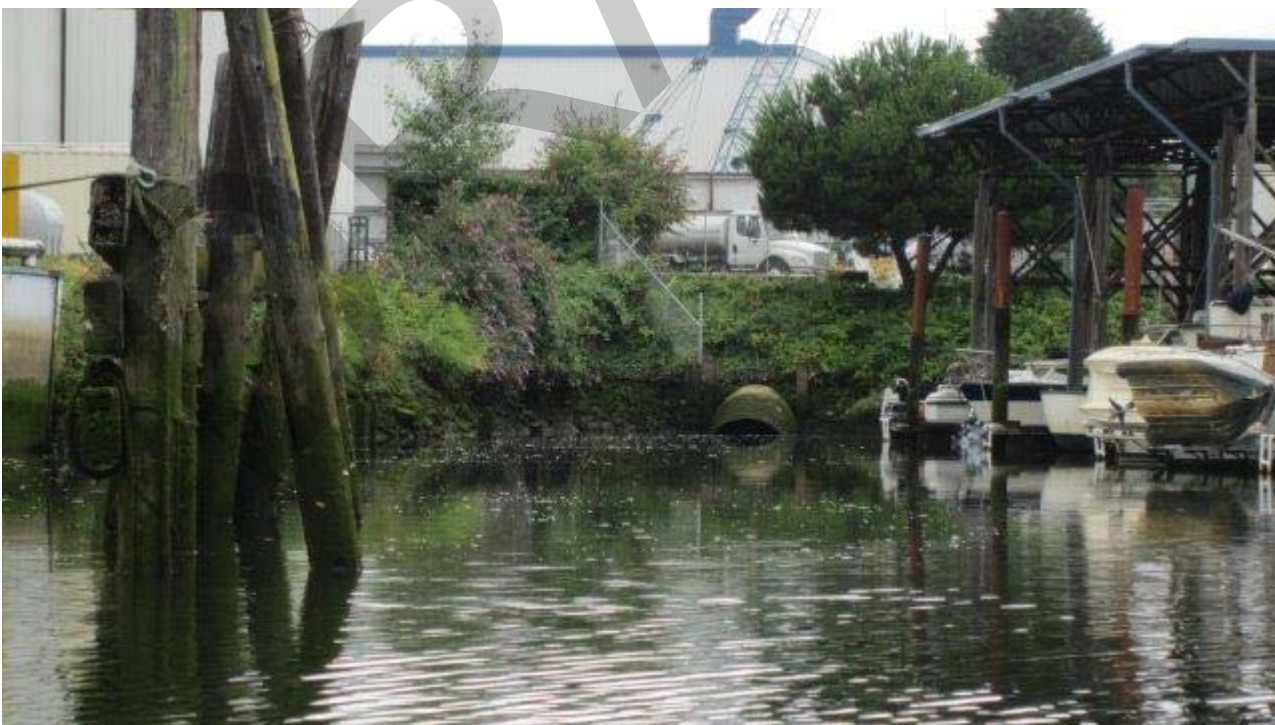
- Corrugated steel pipe projecting between soldier pile wall with a bend (Photos 1 and 2).
- Moss growth around the pipe (Photo 1).
- Pipe size, material, and support condition were not observed.

Photo OF22-02: Outfall at Lower Tide Level

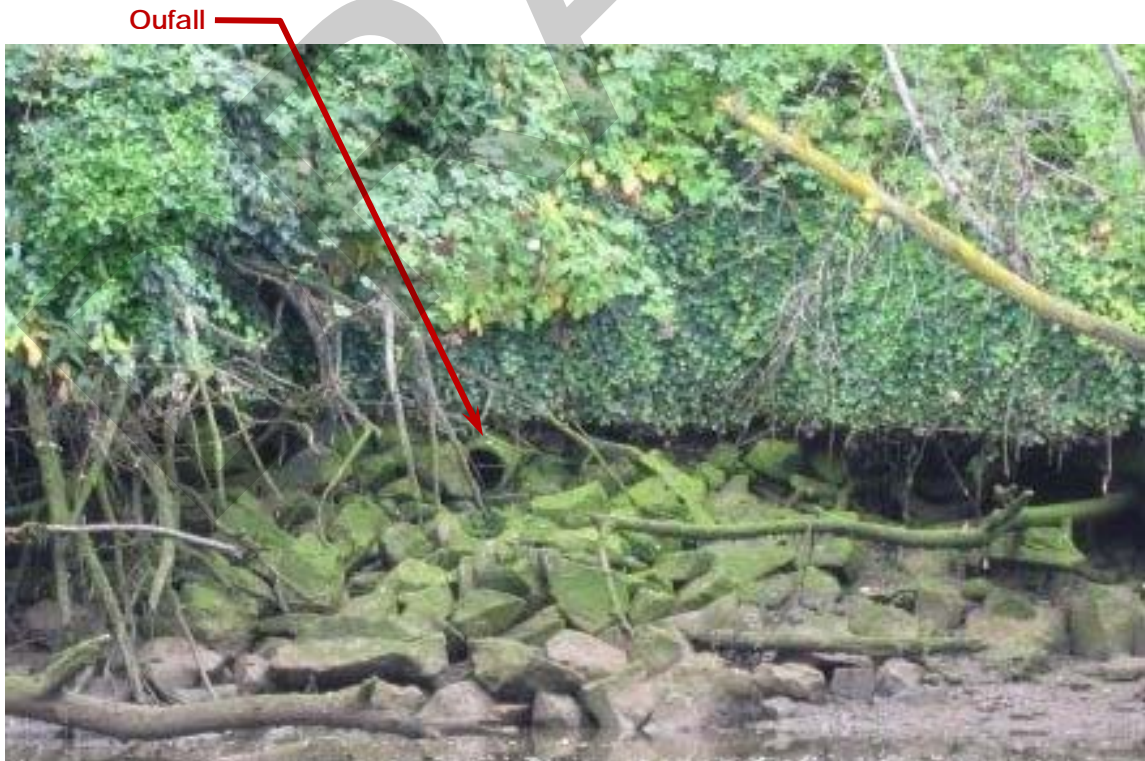
- Outfall projects into the shoreline and is supported on a mound of riprap (Photos 1 and 2).
- Size, material, and condition were not observed closely.

Photo OF23-02: Close Up of Outfall

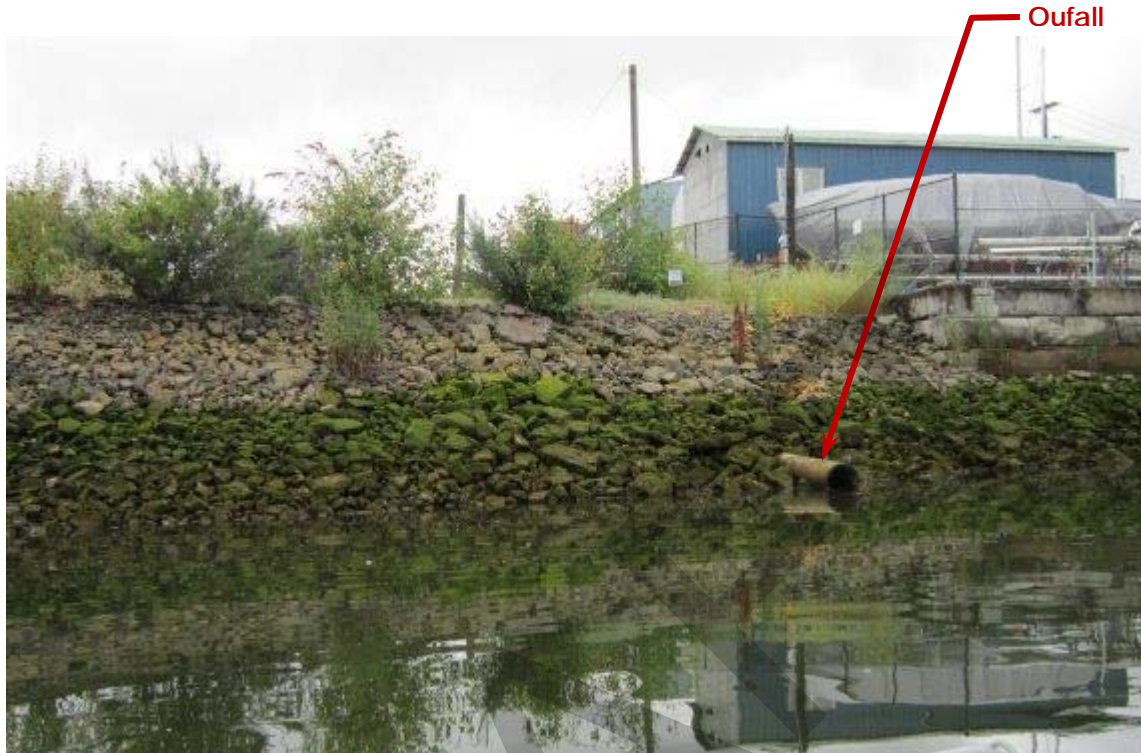
- Outfall projects beyond the riprap shoreline (Photo 1).
- Size, material, and condition were not observed closely.

Photo OF24-01: Outfall (Looking West)

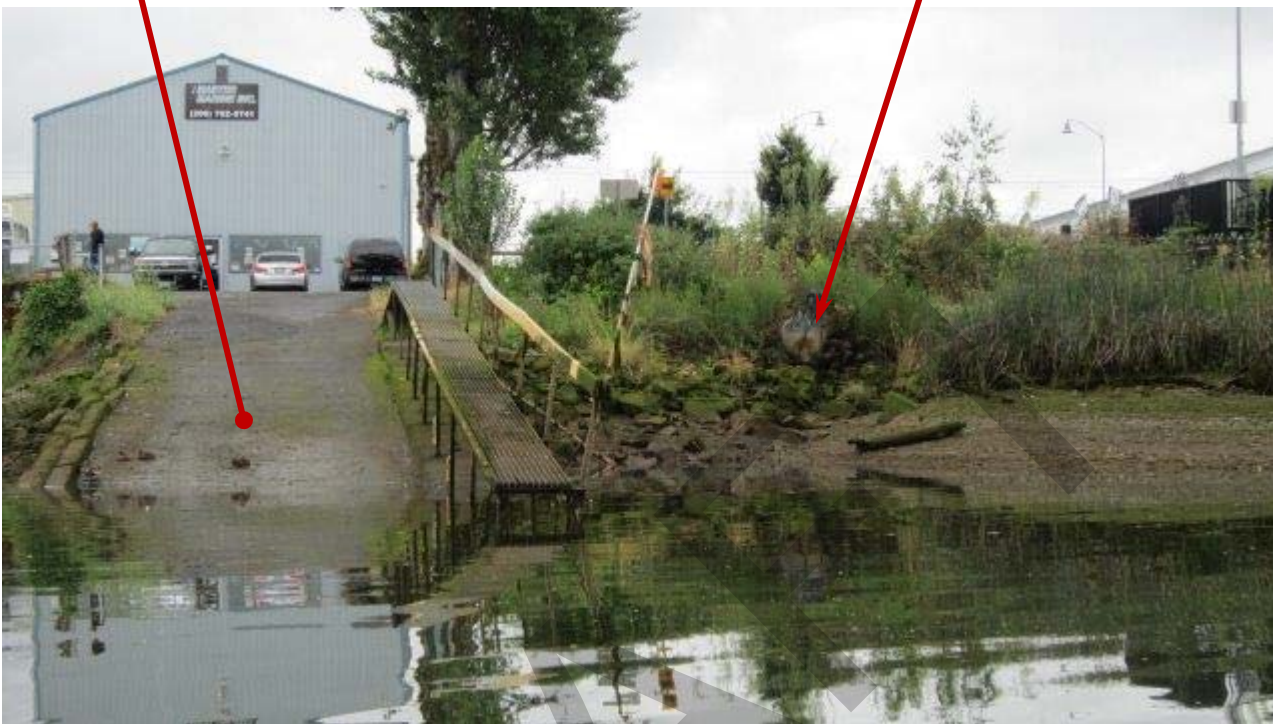
- Outfall with duckbill valve near the shoreline supported on a mound of quarry spalls (Photos 1 to 3).
- Size, material, and condition were not observed closely.

Photo OF25-01: Outfall (Looking West)

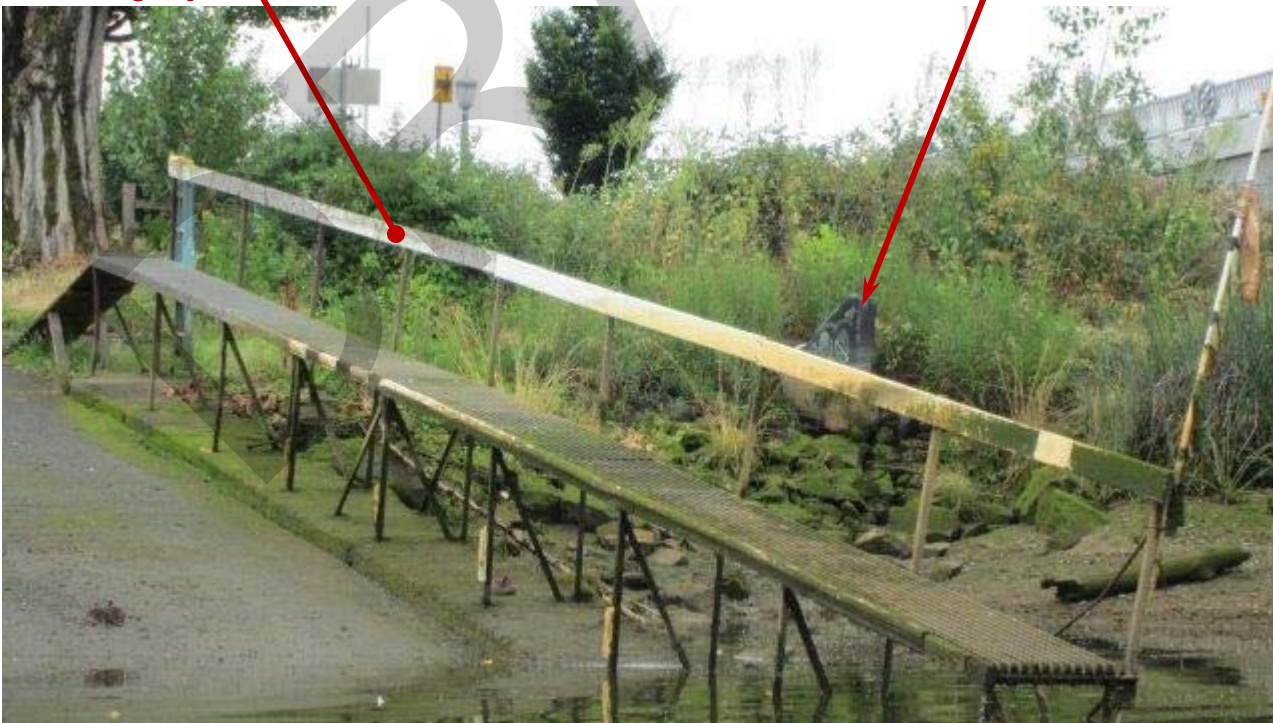
Photo OF25-02: Outfall (Looking Northwest)

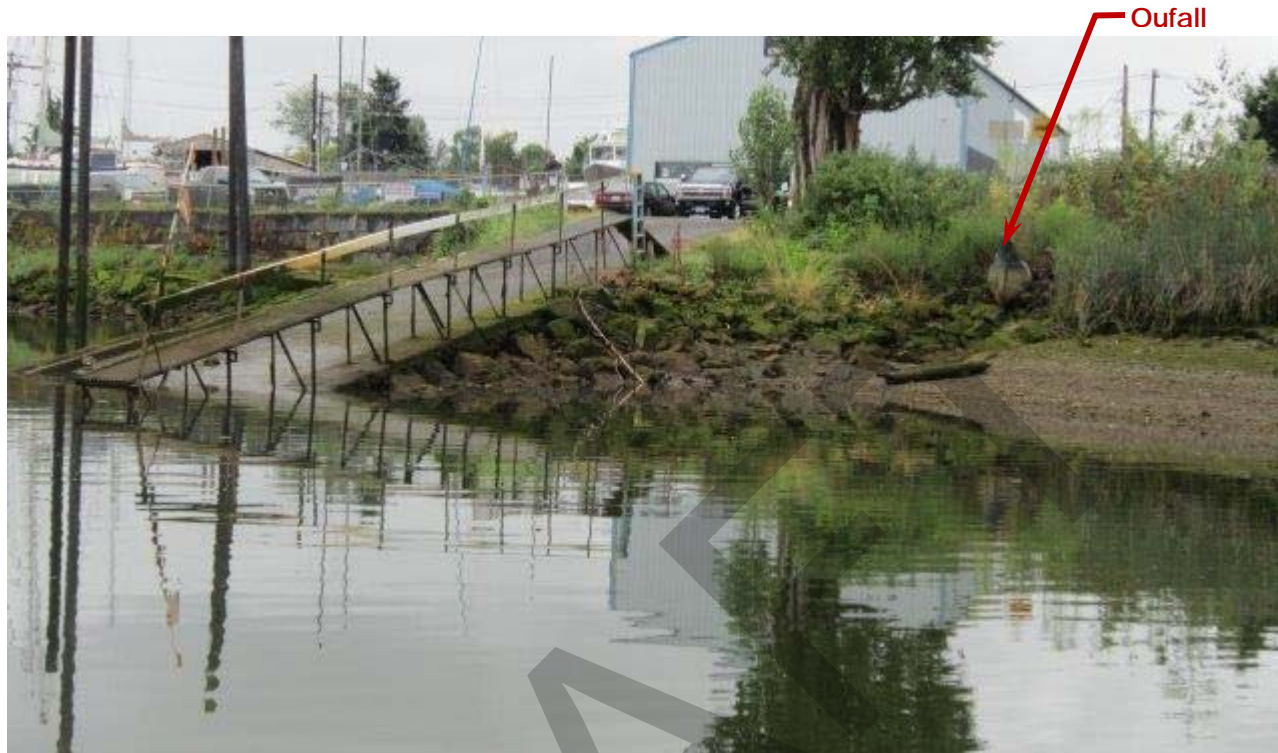
Photo OF25-03: Outfall (Looking Southwest)

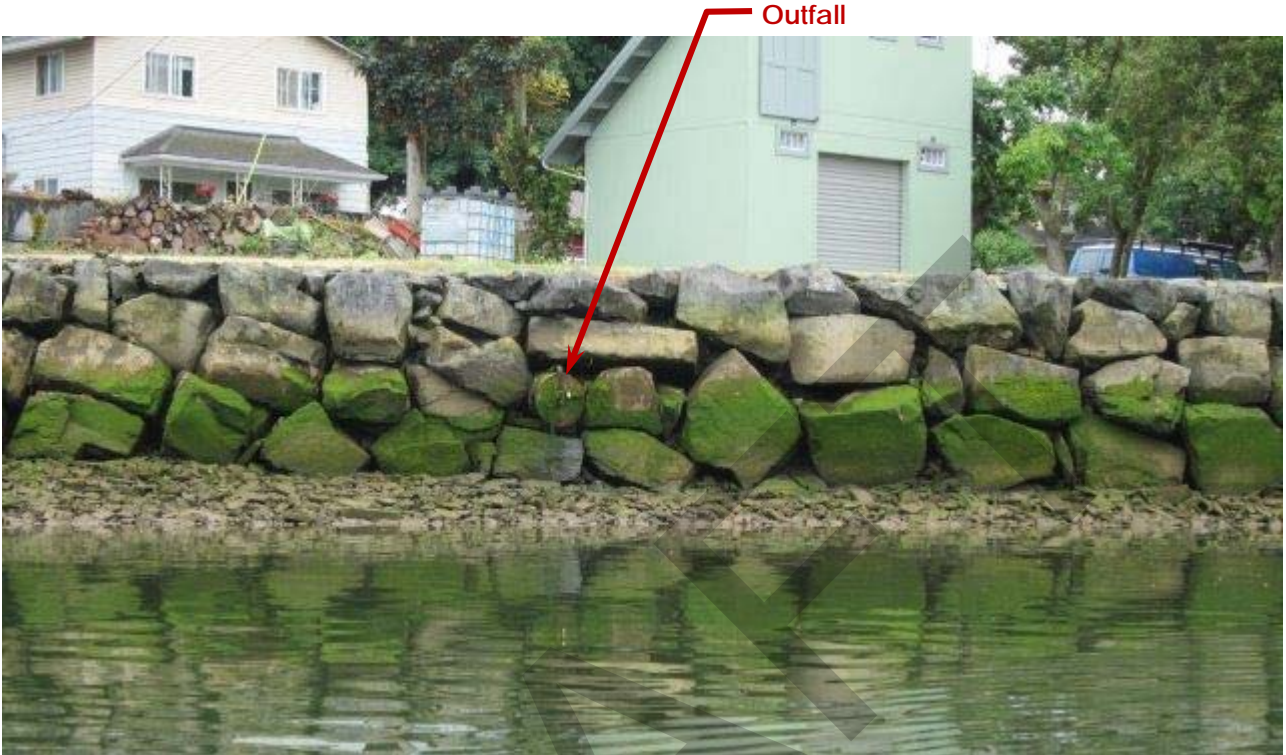
- Outfall with flapgate nestled within rockery wall (Photo 1).
- Size, material, and condition were not observed closely.

Photo OF26-01: Outfall (Looking West)
